# Paris Airport Terminal, 05-2004

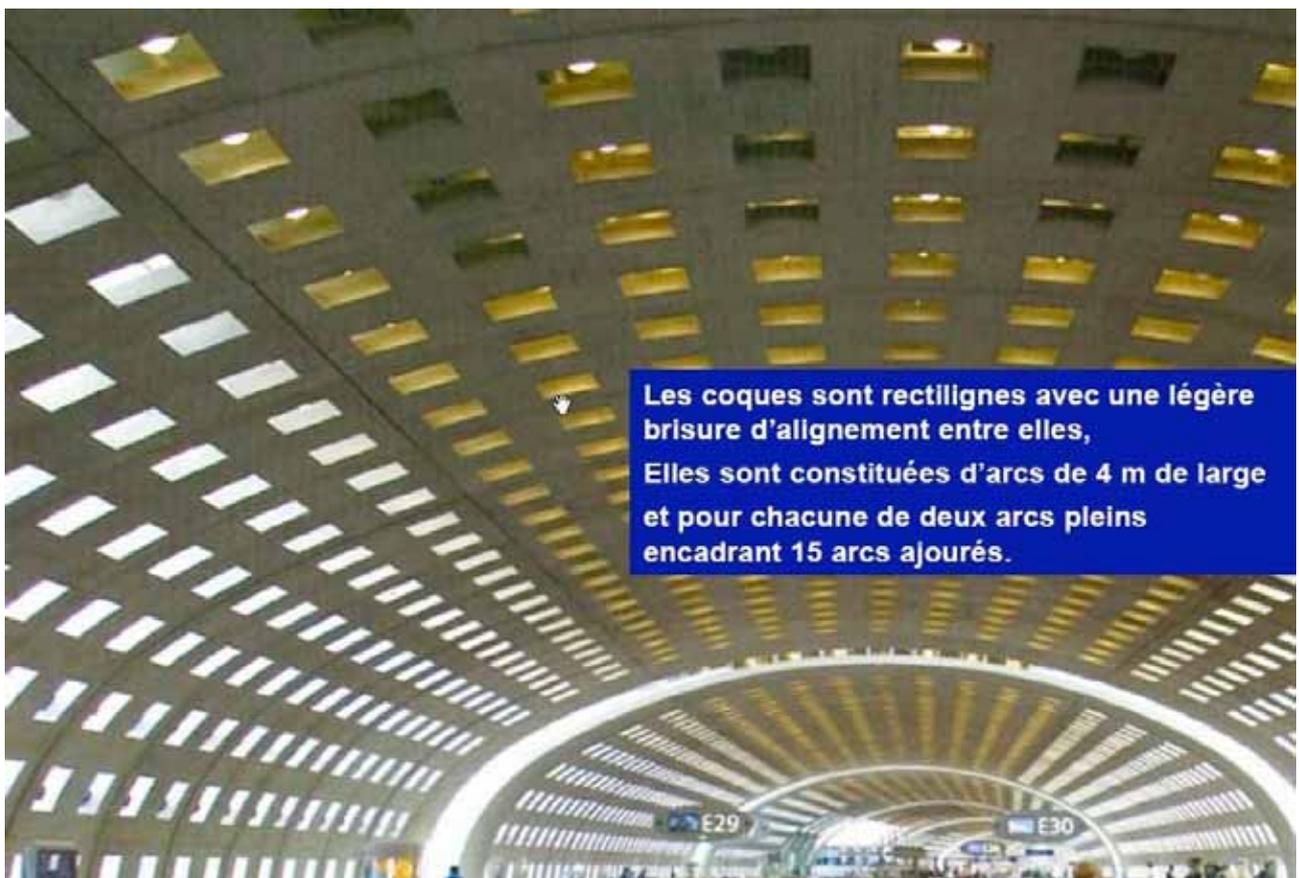
## Internal view

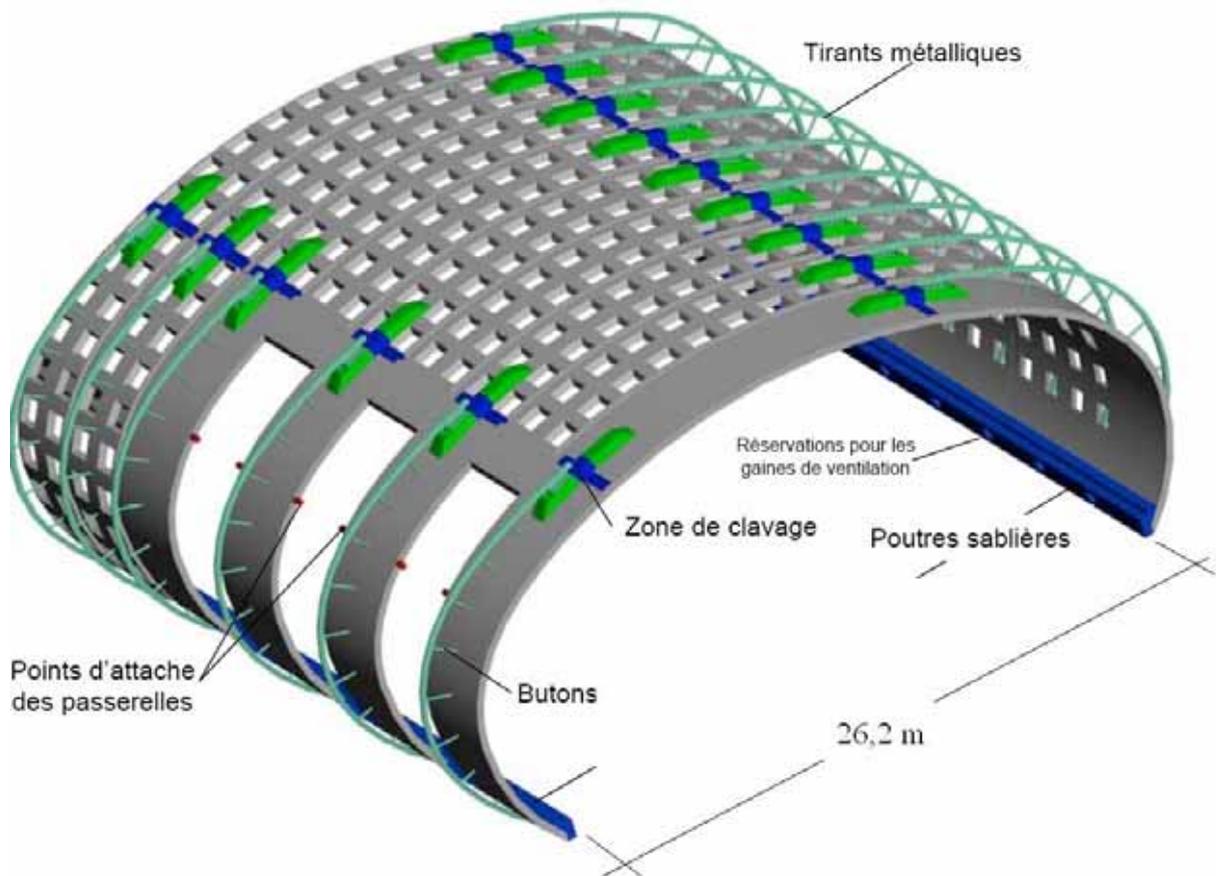
# Structural system

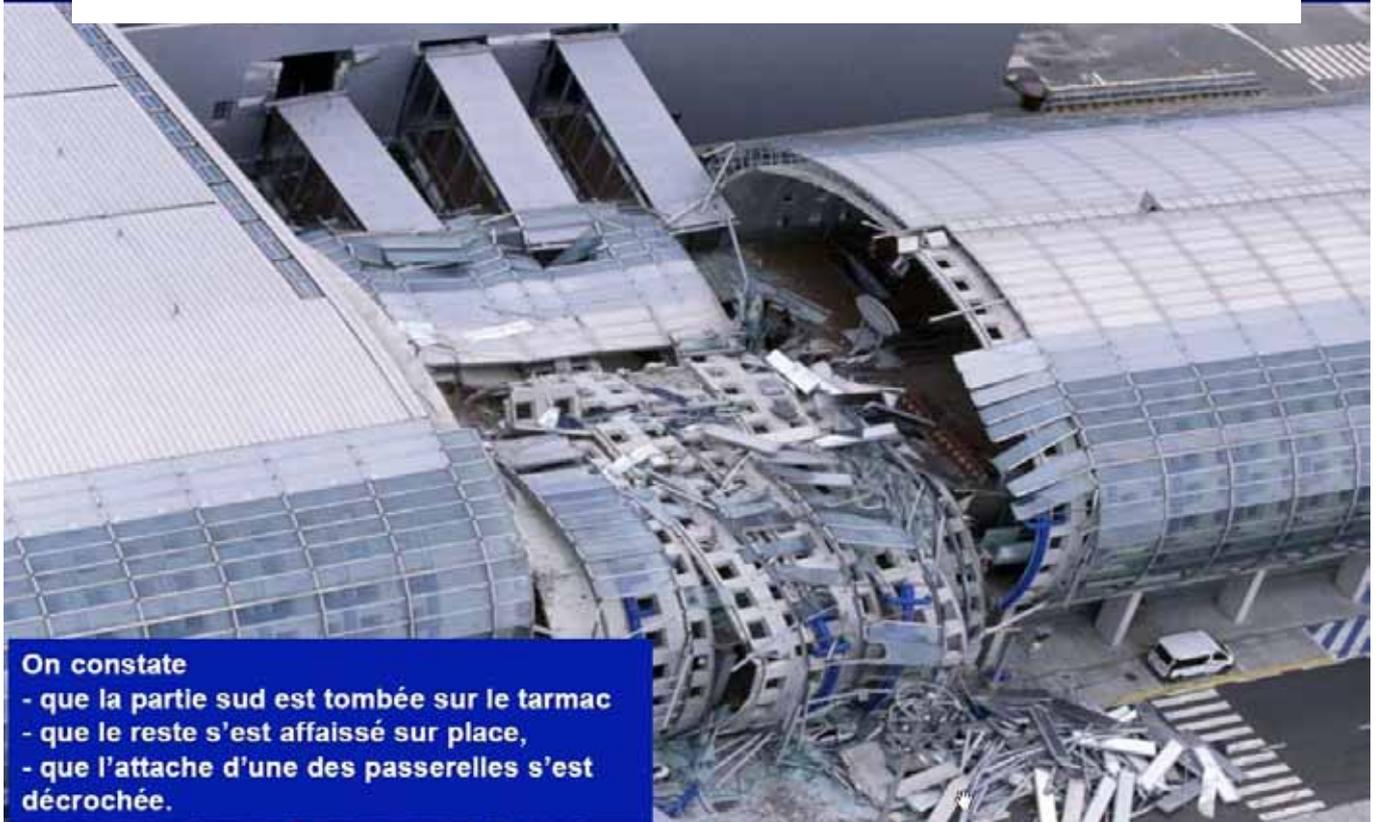
## Failure zone

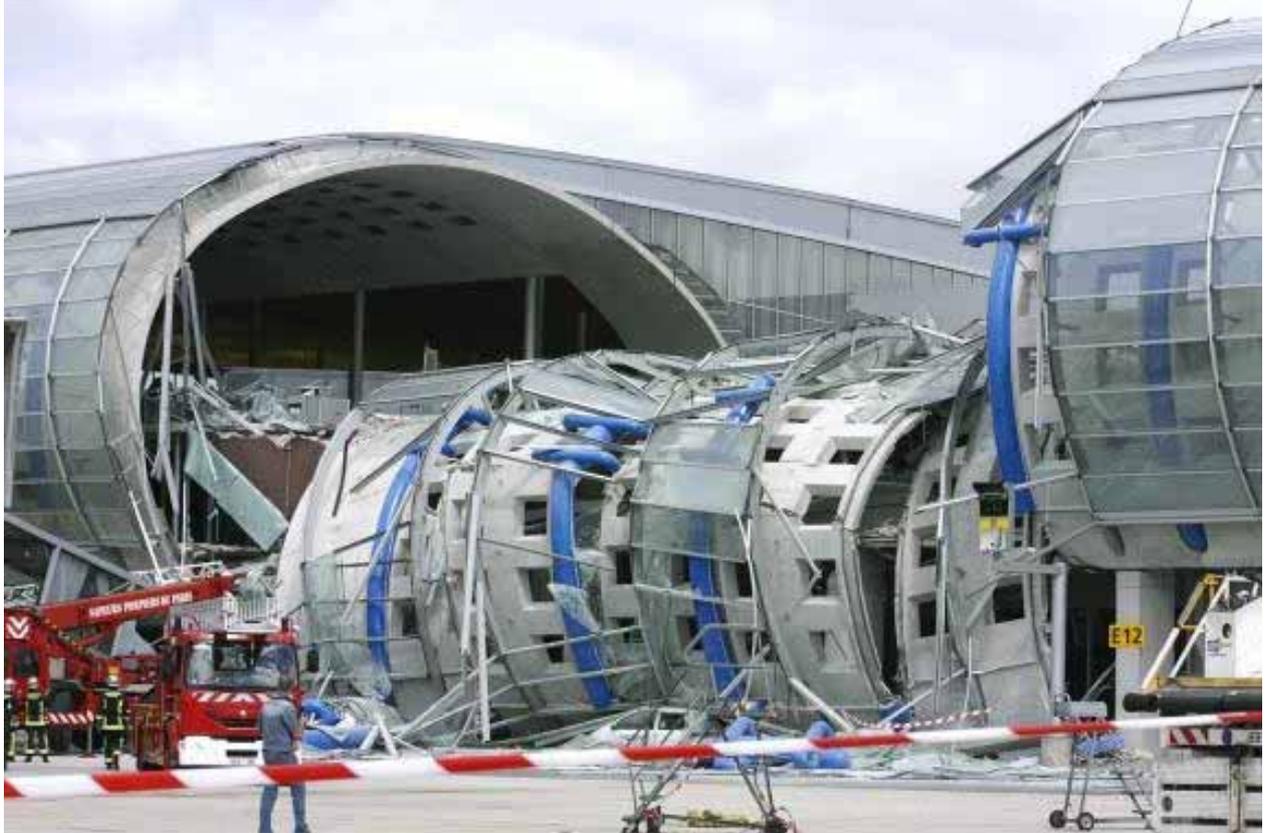
# Failure zone

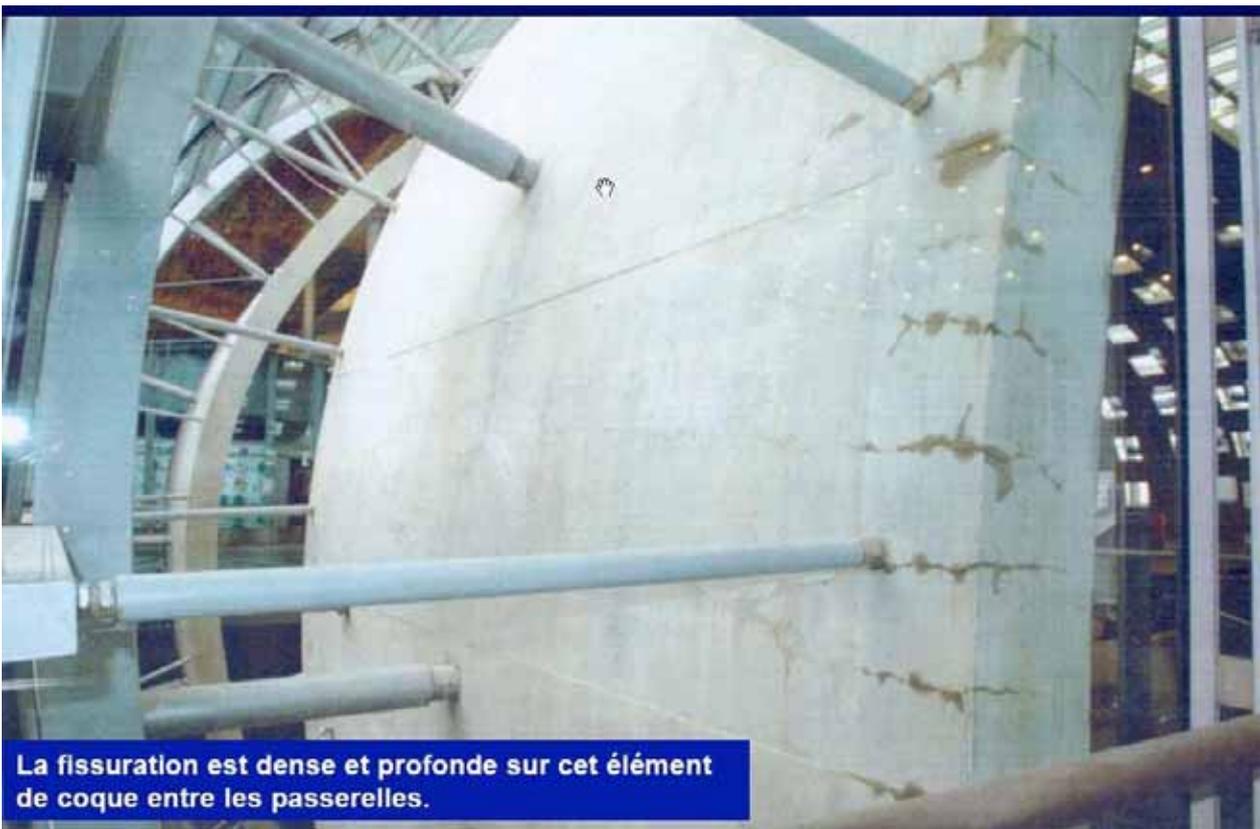
## Cracks of the outer surface of the shell

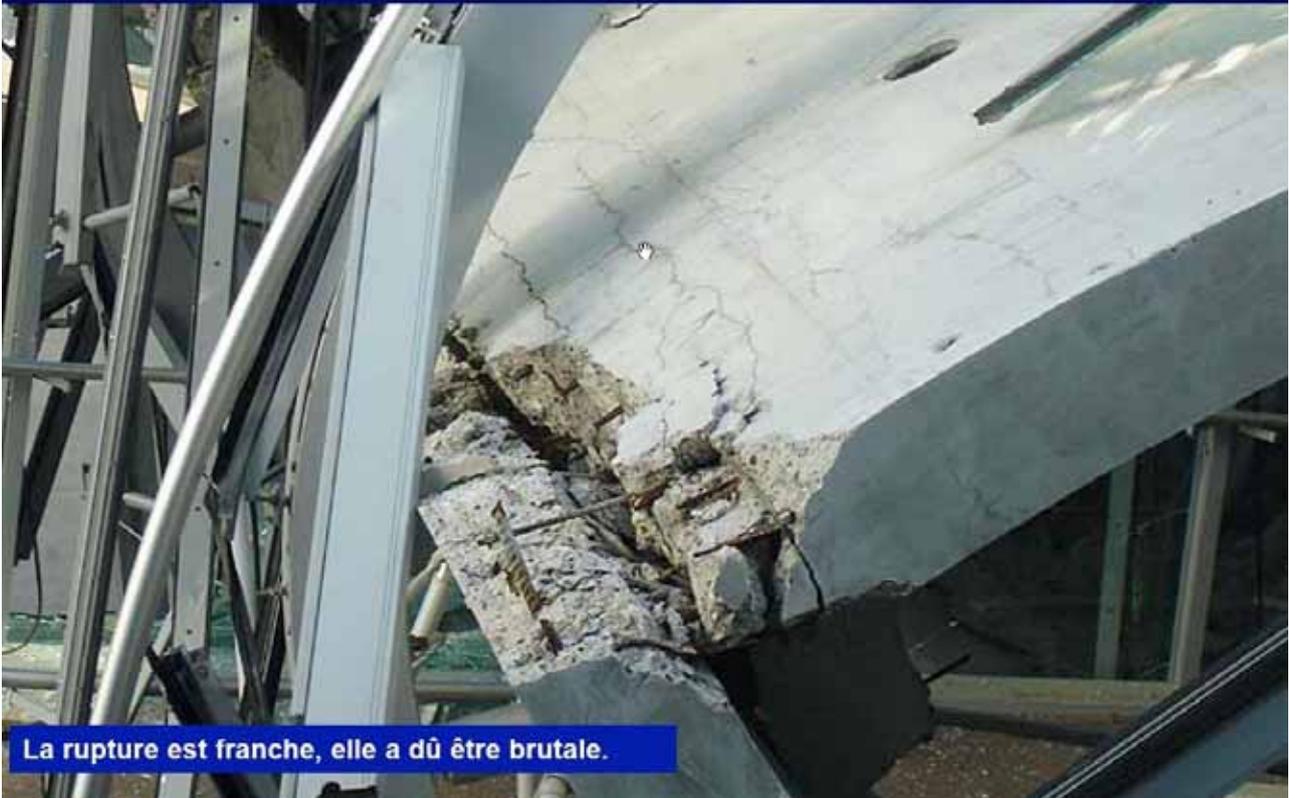
# Rupture of concrete shell

## Détail de la surface de rupture

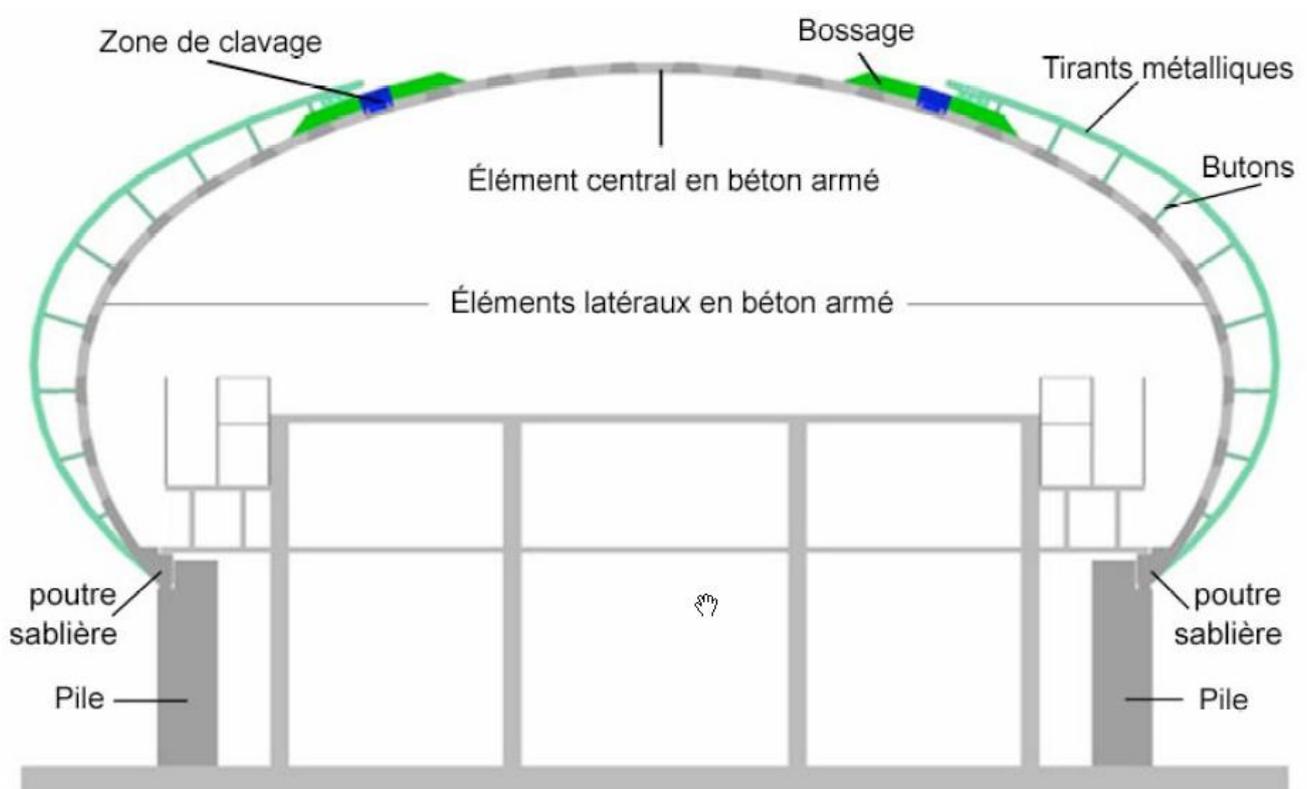
## Transverse section

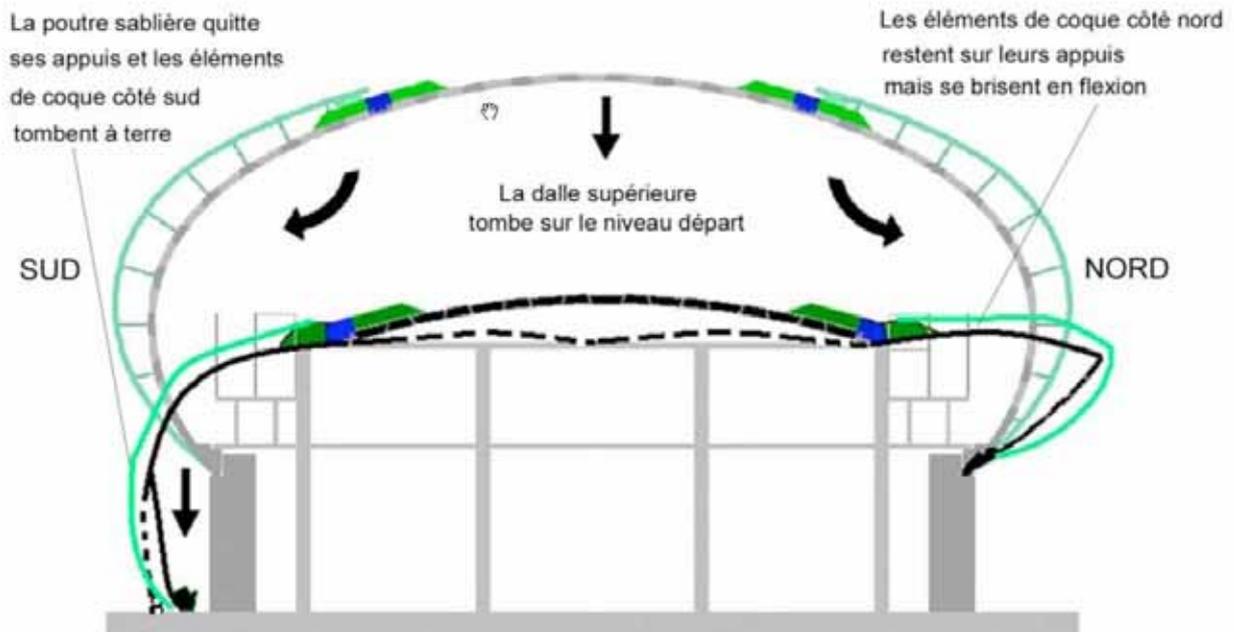
# Scheme of the collapse

Low initial reserve of strength and progressive weakening due to cracking during construction and cycles of stress from differential thermal and moisture movements between concrete shell and curved steel member and struts

- the high flexibility was increased by cracking
- a lack of robustness and redundancy
- the high local punching stresses
- weakness of the longitudinal support beam and its horizontal ties to the columns
